CASE STUDY

STRUCTURAL SLAB CRACK REPAIR - ENGINEERED SOLUTIONS FOR COMMERCIAL STRENGTHENING

OREGON, USA

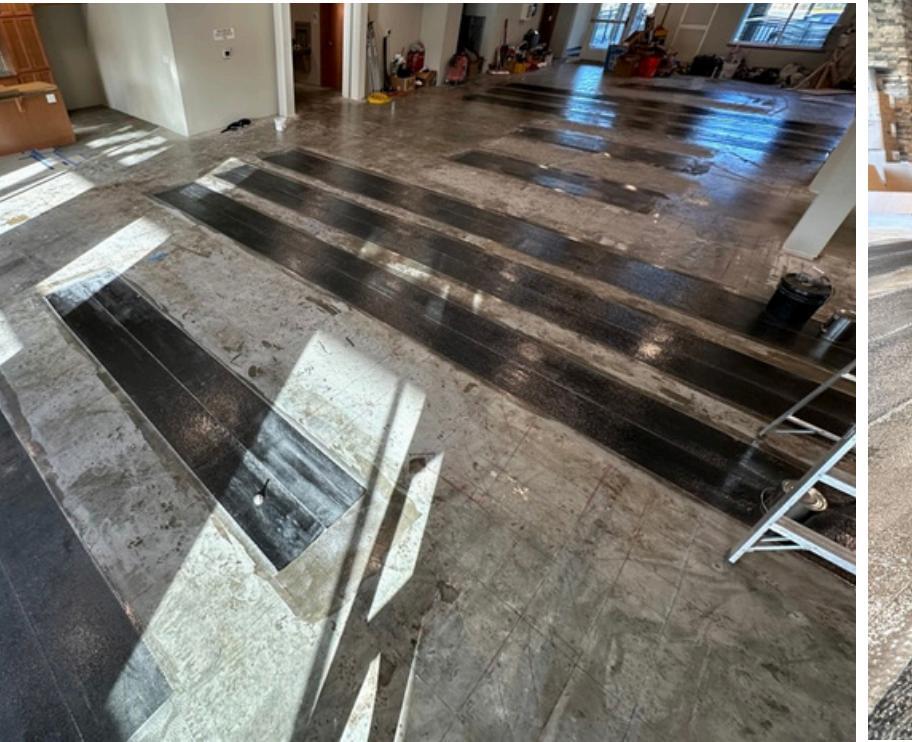
Throughout the test, various parameters are measured and recorded, including the applied force, the deformation or displacement of the FRP, and the corresponding strain. These data points help characterize the mechanical behavior of the carbon fiber bond. This analysis helps assess the effectiveness of the repair and ensures it meets the required specifications. In this case, due to the strength of the concrete being tested, the machine was maxed out at 3,500 psi and no failure was achieved.

The results of the pull test are interpreted to confirm an adequate bond of the carbon fiber to the concrete substrate and made available immediately to share with the engineers of record on the project.
