# PARKING GARAGE STRUCTURAL REPAIR WITH FRP++

CONTRACTOR: UNITED STRUCTURAL SYSTEMS

## PARKING GARAGE STRUCTURAL REPAIR

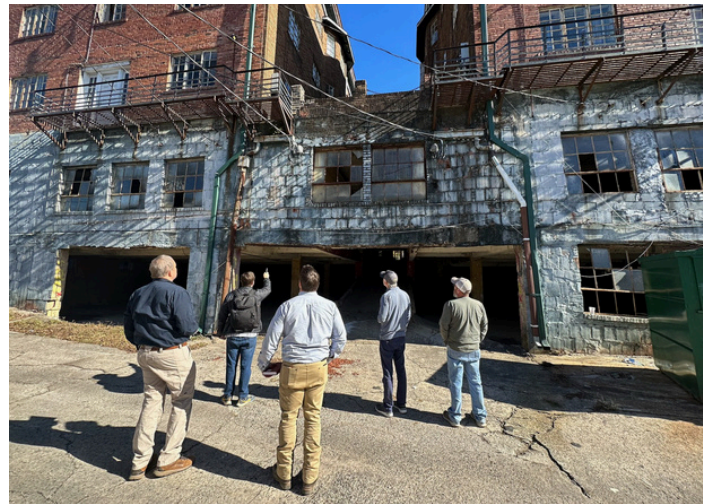
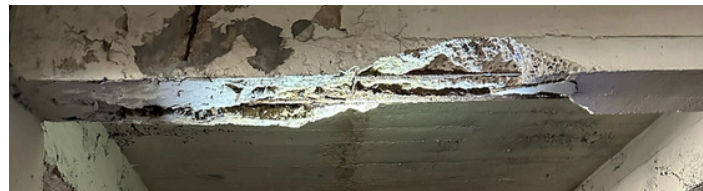
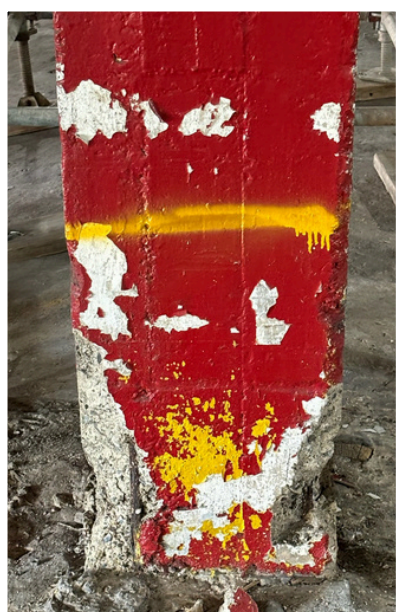
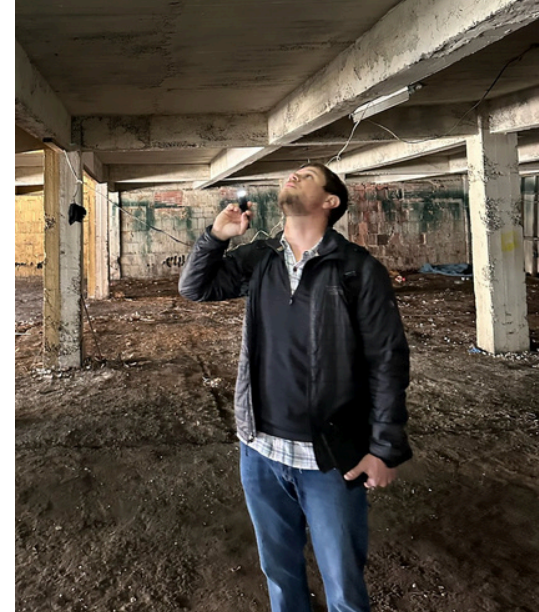
A multi-level parking garage was experiencing severe structural deterioration, including cracked concrete, exposed reinforcement, and compromised load-bearing elements. SRS partnered with USS to evaluate the damage and assist the Engineer of Record (EOR) in developing effective repair solutions to restore the structure's integrity.

To restore the structural integrity of the parking facility, SRS-600UNI Carbon Fiber Reinforcement System was selected for its high tensile strength, lightweight application, and ability to conform and bond seamlessly to concrete surfaces.

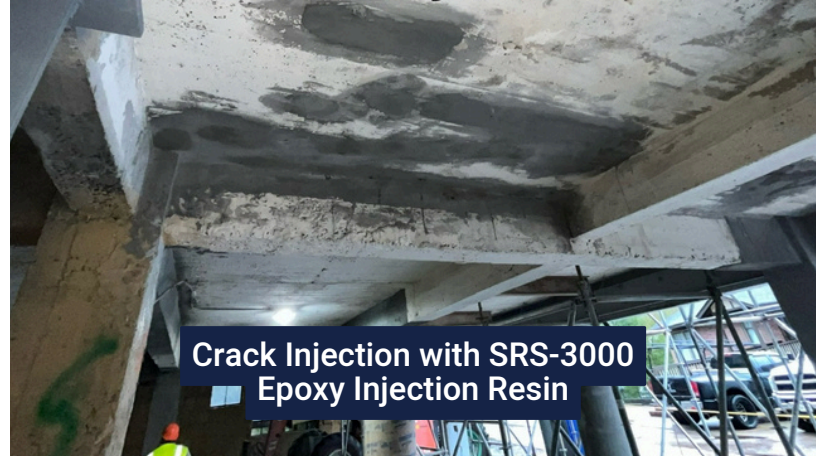
- Surface Prep – Loose concrete was removed
- Corrosion Mitigation – SRS-4100 Steel Guard was applied to prevent further deterioration of exposed rebar and reduce demolition
- Concrete Treatment – SRS-4000 Concrete Guard was utilized to strengthen existing concrete by reducing porosity, preventing future moisture infiltration, and improving adhesion of FRP
- FRP Application – SRS-600UNI carbon fiber fabric was installed using SRS-1000 structural epoxy, reinforcing critical structural elements
- Protective Coating – A final sealant was used to safeguard against moisture and environmental exposure

- Restored Structural Integrity – Carbon fiber reinforcement restored the strength and stability of critical load-bearing components
- Increased Load Capacity – The application of high-strength carbon fiber significantly enhanced the structural capacity to support vehicle loads
- Cost-Effective Solution – Reinforcing existing elements eliminated the need for costly demolition and rebuilding
- Long-Term Durability – The combination of carbon fiber reinforcement and corrosion protection provided a lasting, reliable solution
