CASE STUDY

STRUCTURAL SLAB CRACK REPAIR - ENGINEERED SOLUTIONS FOR COMMERCIAL STRENGTHENING

OREGON, USA

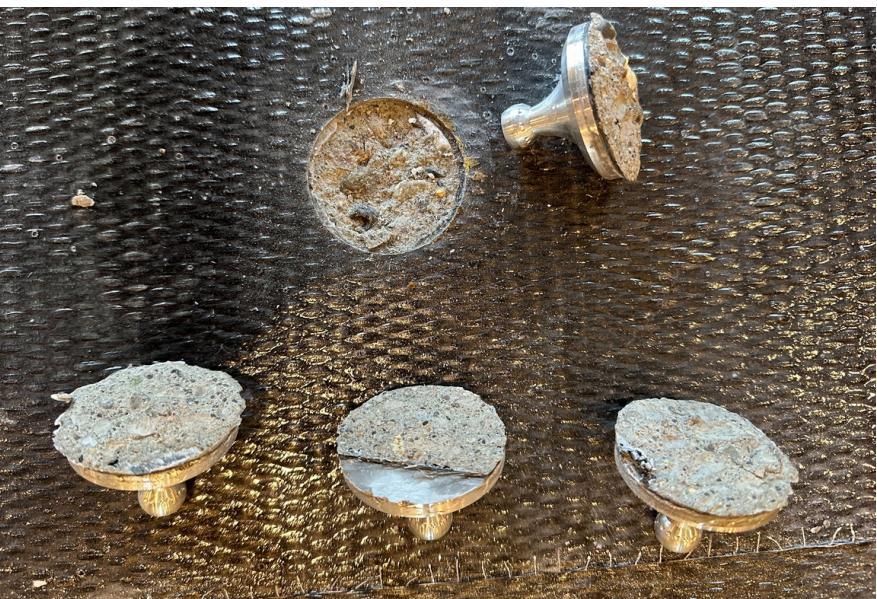
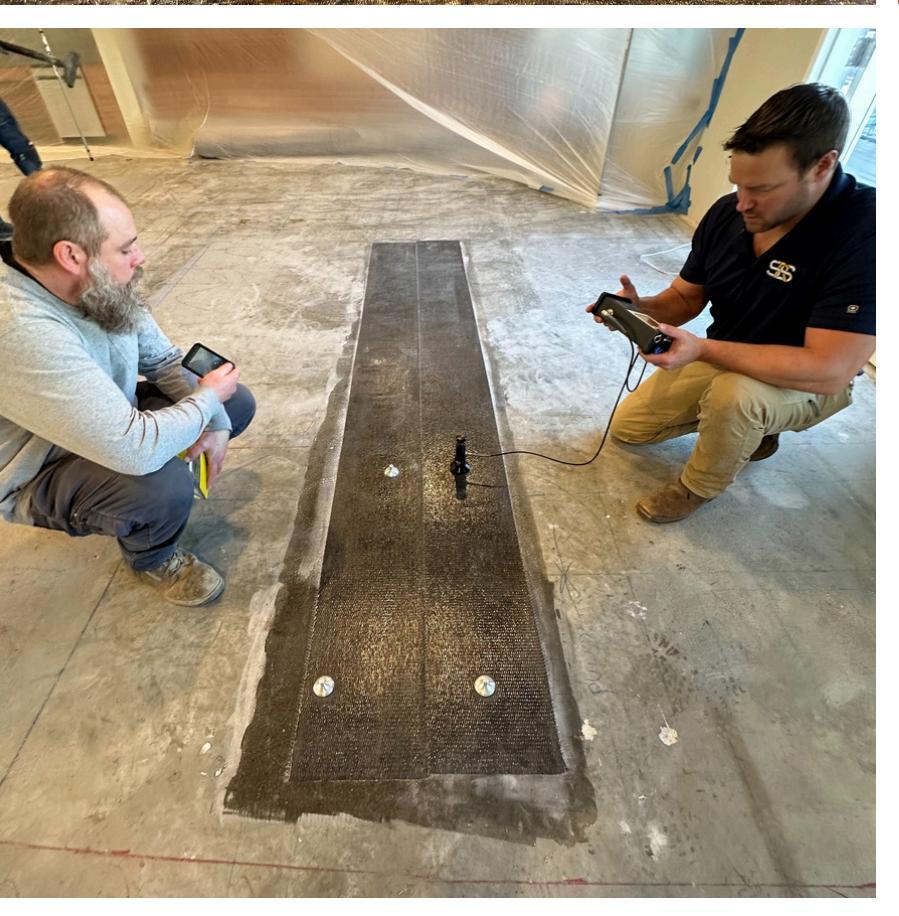
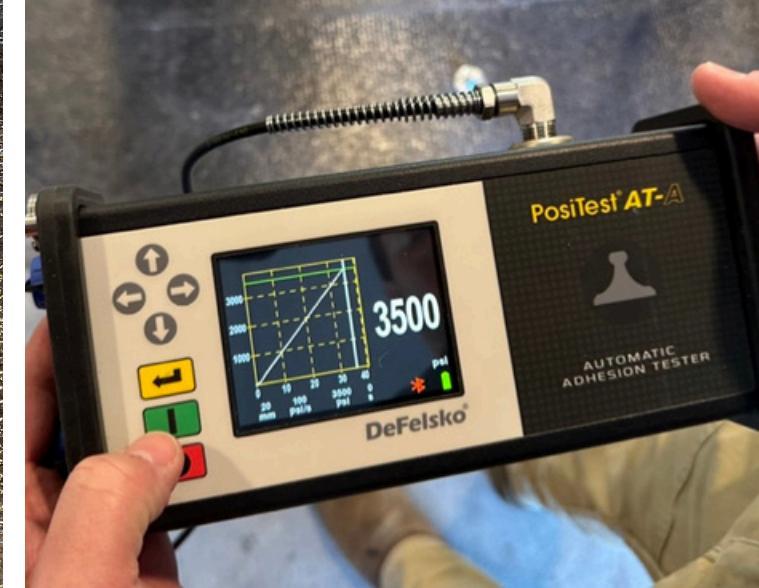
To ensure the safety and performance of the carbon fiber application, bond tests were performed to provide confirmation of the strength and reliability of the FRP system. In order to test the bond strength of the system, dolly's are epoxied to the surface of the FRP. Once cured, the FRP around the dolly is cut in order to isolate the pull-off test to a known area. The test is then carried out to confirm a failure in the substrate rather than in the bond to the substrate.

A controlled force is applied to the repaired area using aluminum dollies, gradually increasing until the structure reaches its breaking point or until the desired data is obtained. The force can be applied at a constant rate to measure the stress-strain relationship accurately.

Throughout the test, various parameters are measured and recorded, including the applied force, the deformation or displacement of the FRP, and the corresponding strain. These data points help characterize the mechanical behavior of the carbon fiber bond. This analysis helps assess the effectiveness of the repair and ensures it meets the required specifications. In this case, due to the strength of the concrete being tested, the machine was maxed out at 3,500 psi and no failure was achieved.

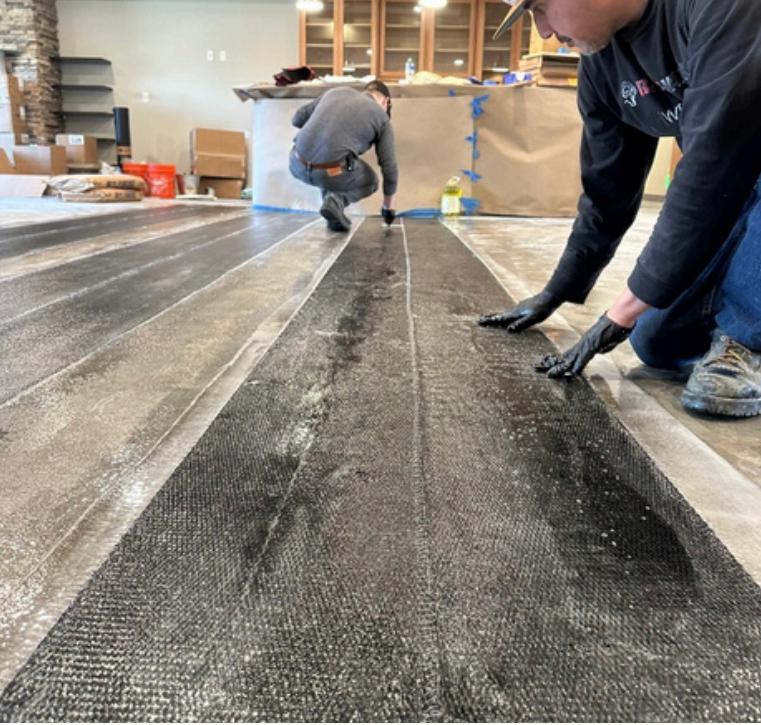
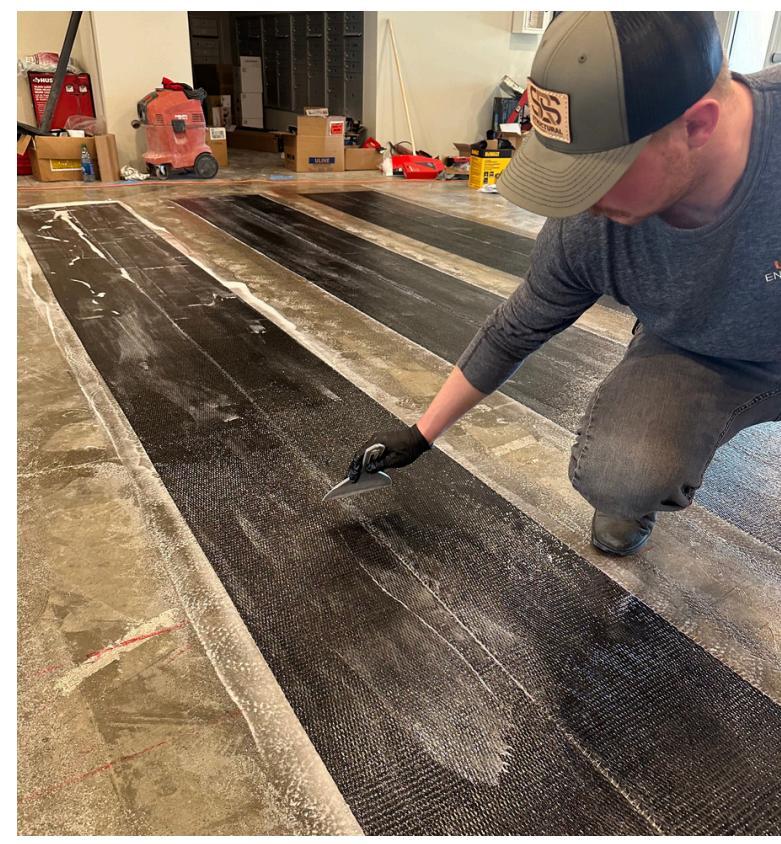
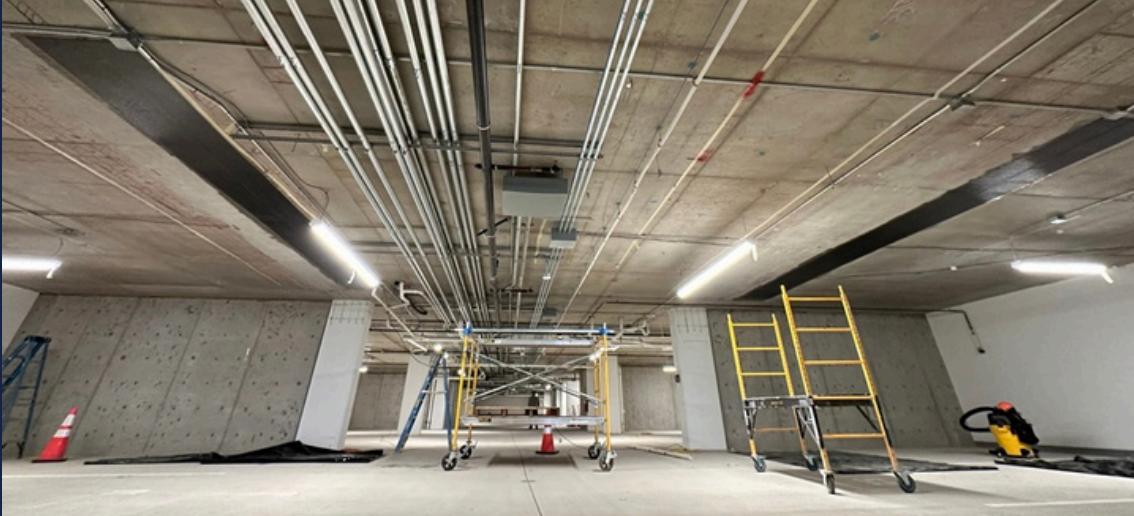
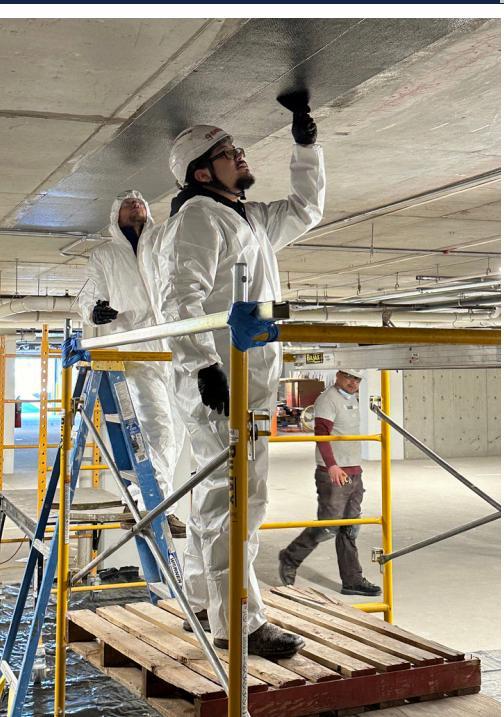
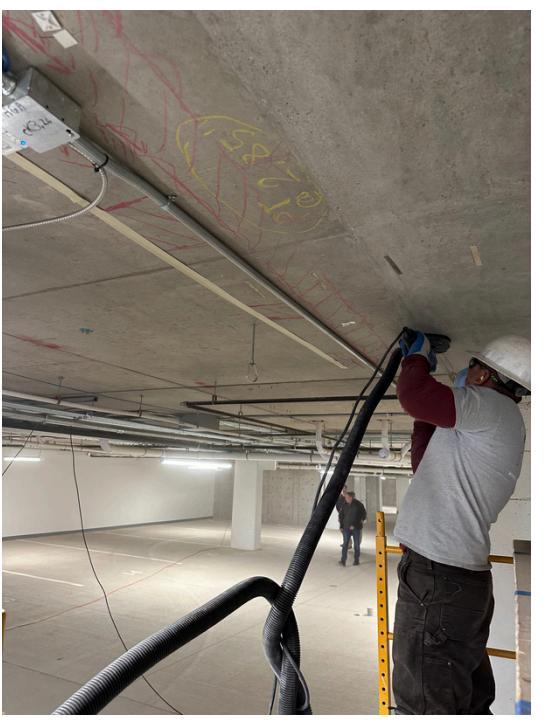
Since Carbon fiber composites offer exceptional strength-to-weight ratios with minimal thickness, SRS-600 Unidirectional carbon fiber was specified to strengthen the cracked areas of the reinforced slab above the parking garage structure.

With a confinement strength of over 35,000lbs per sq/ft, the 24" SRS-660 Bidirectional carbon fiber extended up the outside face, across the top and down the inside face of the wall cracks.

The primary purpose of the epoxy component of the system is to transfer loads between the concrete substrate and the carbon fiber. A strong bond ensures efficient load transfer, allowing the carbon fiber to effectively supplement the structural capacity of the concrete.
